TECHNICAL REPORT ARCCB-TR-92034

EDDY CURRENT INSPECTION OF GUN TUBES

DAVID CONCORDIA

JULY 1992

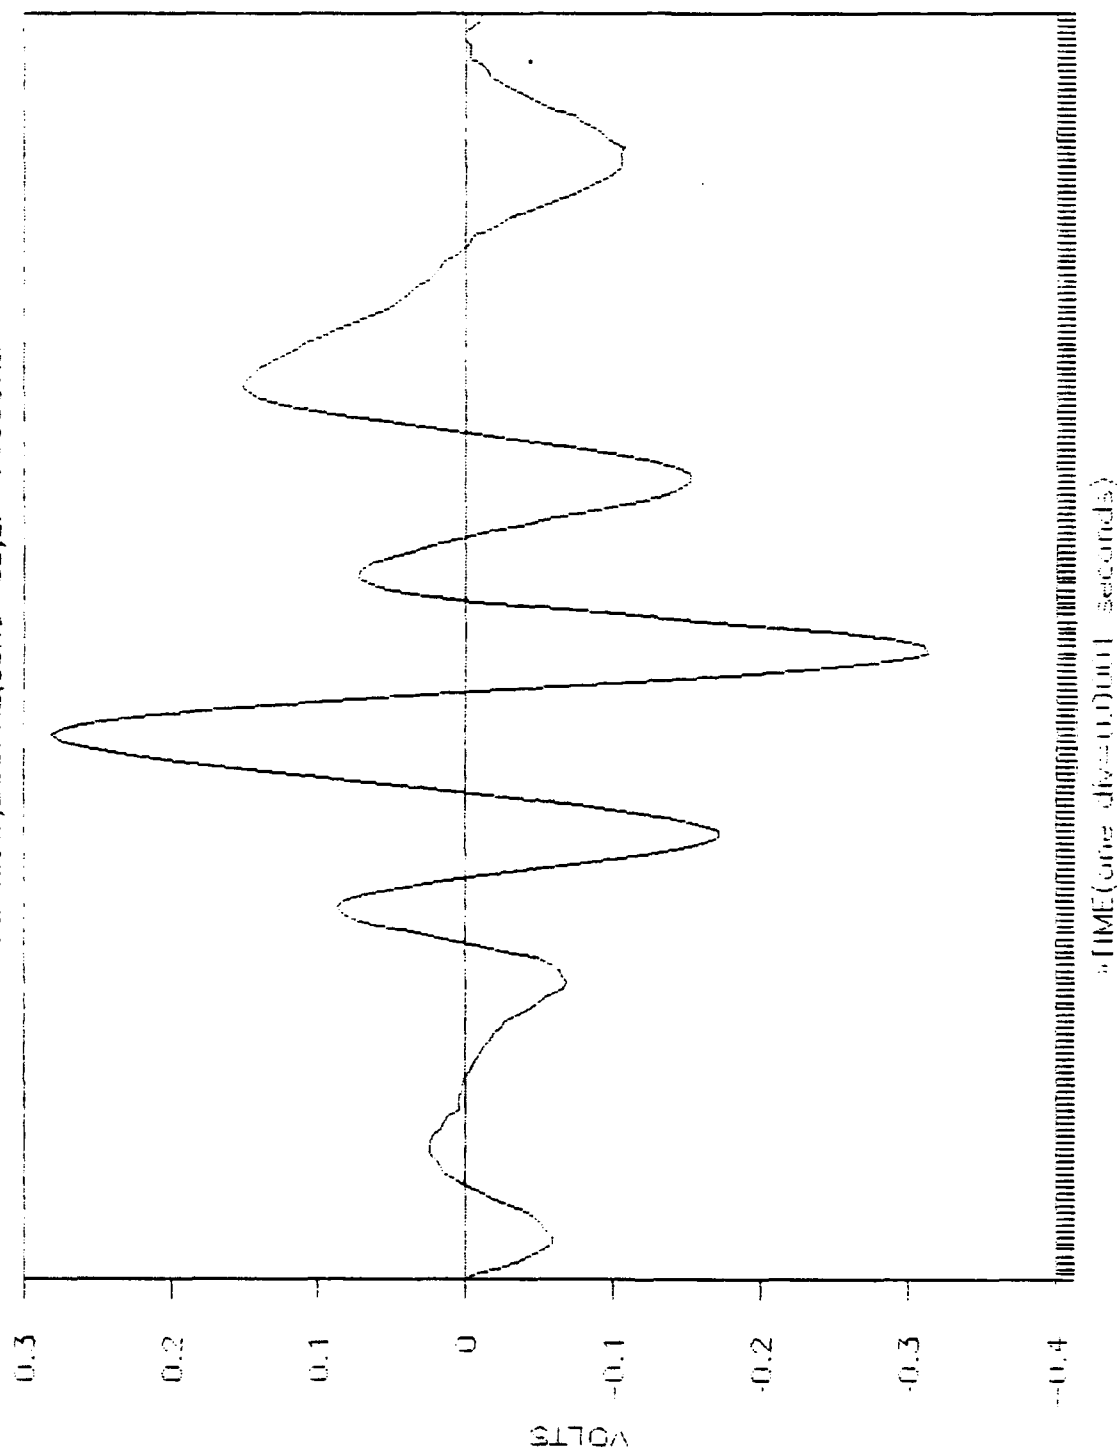
SCALE(120mm # 5526)

F2 filter, 200kHz, sens=62, sr=10000Hz

Figure 15. Signals obtained from scale pocket digitized at 10,000 Hz.

In an attempt to examine the signals more closely, those obtained from quench cracks and scale pockets were digitized at a sampling rate of 10,000 Hz. The results are shown in Figures 14 and 15, respectively. Unfortunately, this closer examination of the signals did not reveal a discernible difference between the two signals. At that point, a decision was made to concentrate on preparing the system to inspect tubes after rough-machining in the before-swage condition. Tubes in this condition have a machined ID surface, therefore the problem of scale pockets encountered with the surface condition on as-forged tubes would not be present. Further attempts to develop methods capable of discriminating between scale pocket and defect signals require funding and efforts in excess of this project.

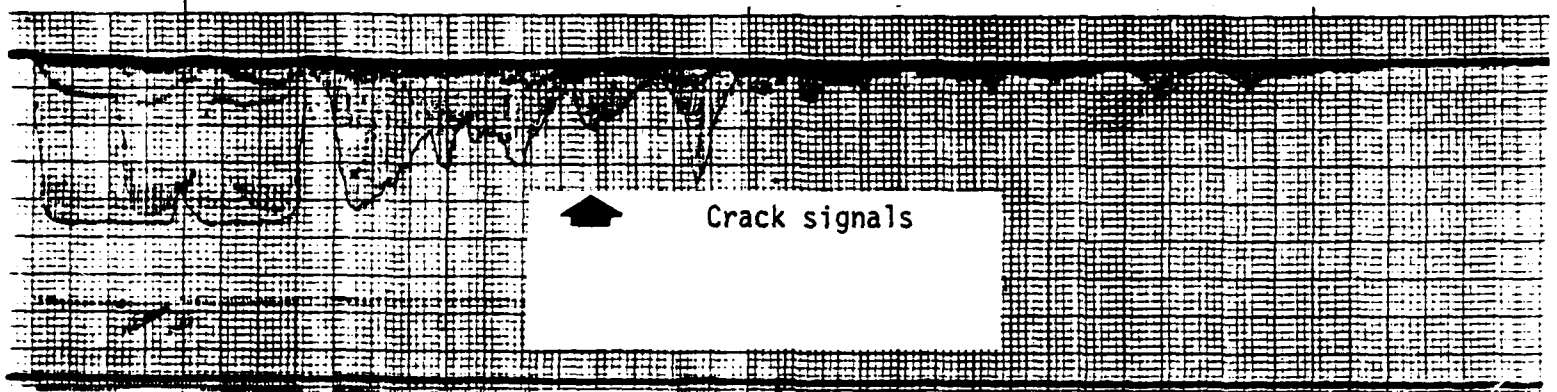
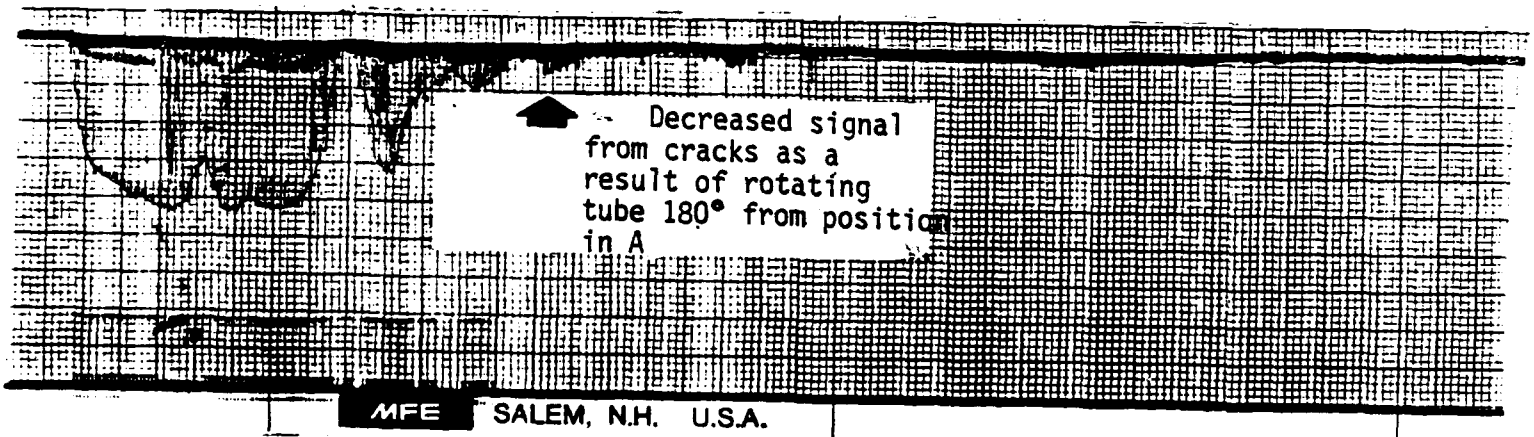
Figure 16. Effect of tube rotation on crack indication using the distance-compensated probe.

The tests conducted on rough-machined tubes using the distance-compensated probe revealed a problem, namely, that the compensation provided by the electronic circuit is nonlinear. The probe assembly tends to sit closest to the bottom surface of the gun tube due to its own weight. This produces a variation in distance between the sensor and the tube surface as the sensor rotates. The nonlinear distance compensation results in an amplitude response when a crack is encountered that depends on how the tube has been placed on the supports. Figure 16 shows two results from tests on a 105-mm tube containing quench cracks. In Figure 16a the quench crack indications near the center of the recording are large enough in magnitude to trigger the threshold channel, which indicates defects are present. Figure 16b shows the recording obtained with the tube rotated 180 degrees from its position in Figure 16a. This change in amplitude is a result of the nonlinear response of the compensation circuit.

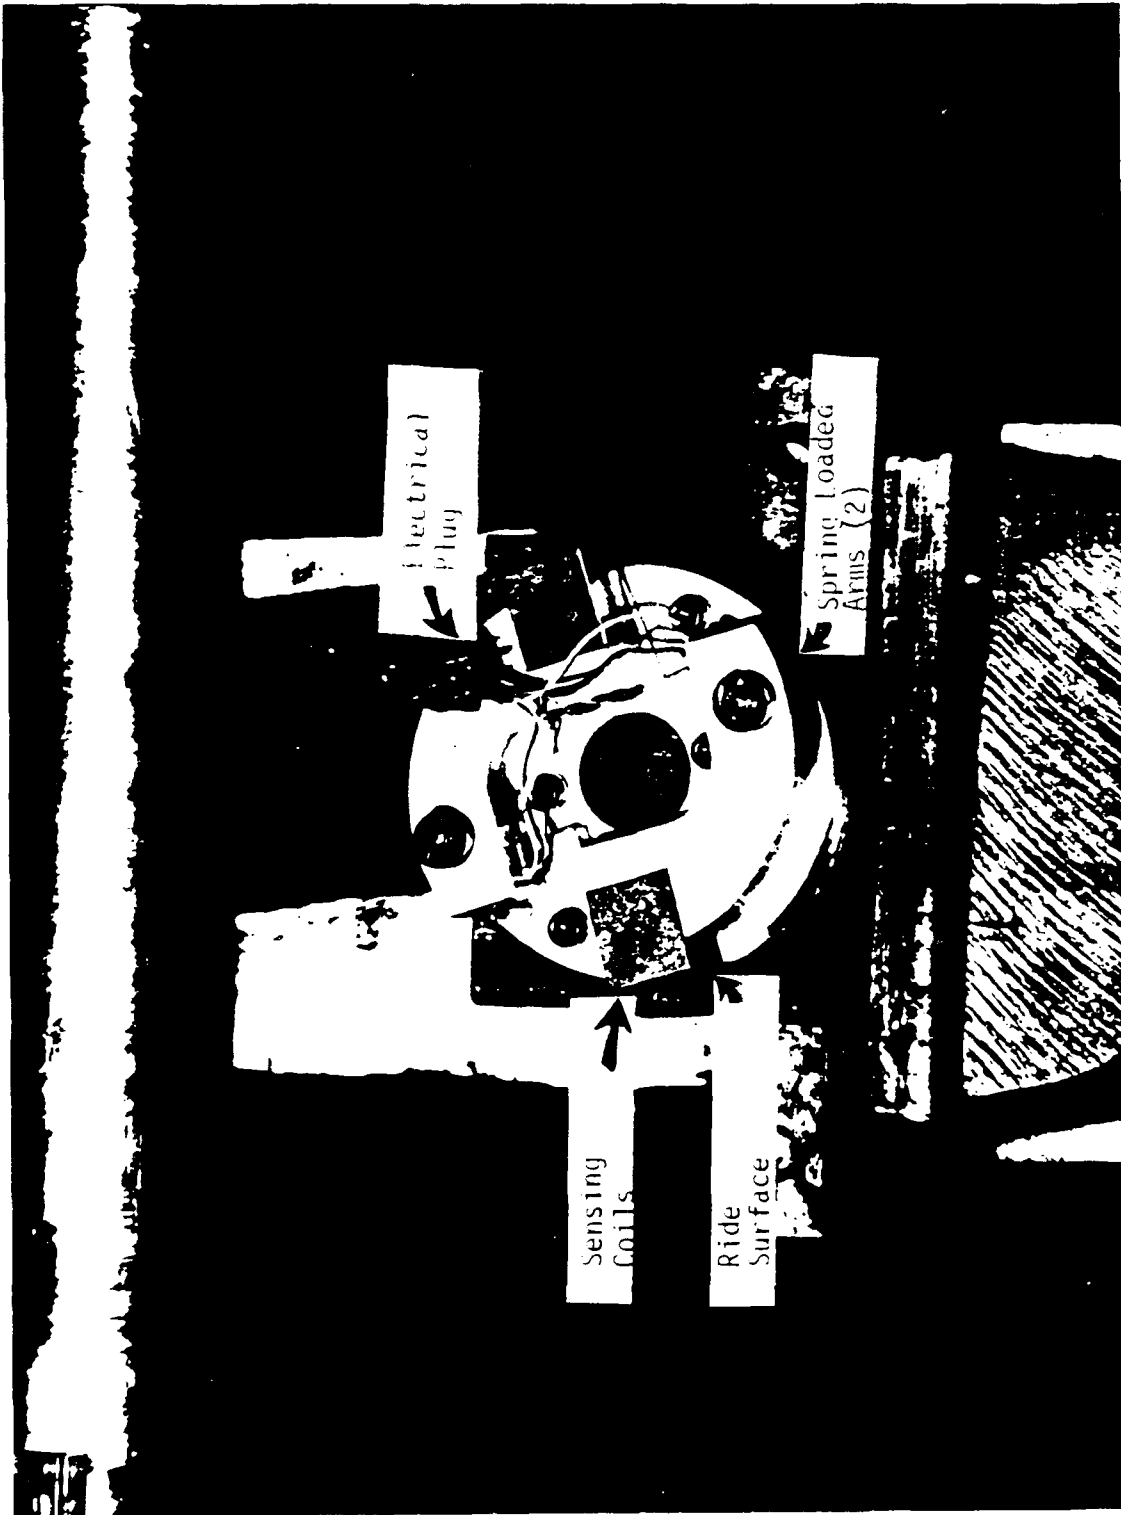
Figure 17 Surface ride probe

A new sensor design, the surface ride probe, was tested to eliminate the need for the distance-compensated circuit. The sensor, shown in Figure 17, uses "shoes" that ride on the surface of the test material. The "shoes" are designed to hold the eddy current sensor coil at a fixed standoff distance (approximately 0.030 inch) from the test material. A test using a 105-mm tube (S.N. 2664) is shown in Figure 18. The upper trace shows the eddy current indications obtained from quench cracks that existed on the ID surface of the tube from 90 to 135 inches from the breech end. The lower trace is the threshold channel, indicating that the threshold voltage has been exceeded. The fixed-distance contact sensor eliminated the problem of varying response when the tube was rotated. Also, the signal-to-noise ratio was somewhat better than with the distance-compensated probe. The following settings were used:

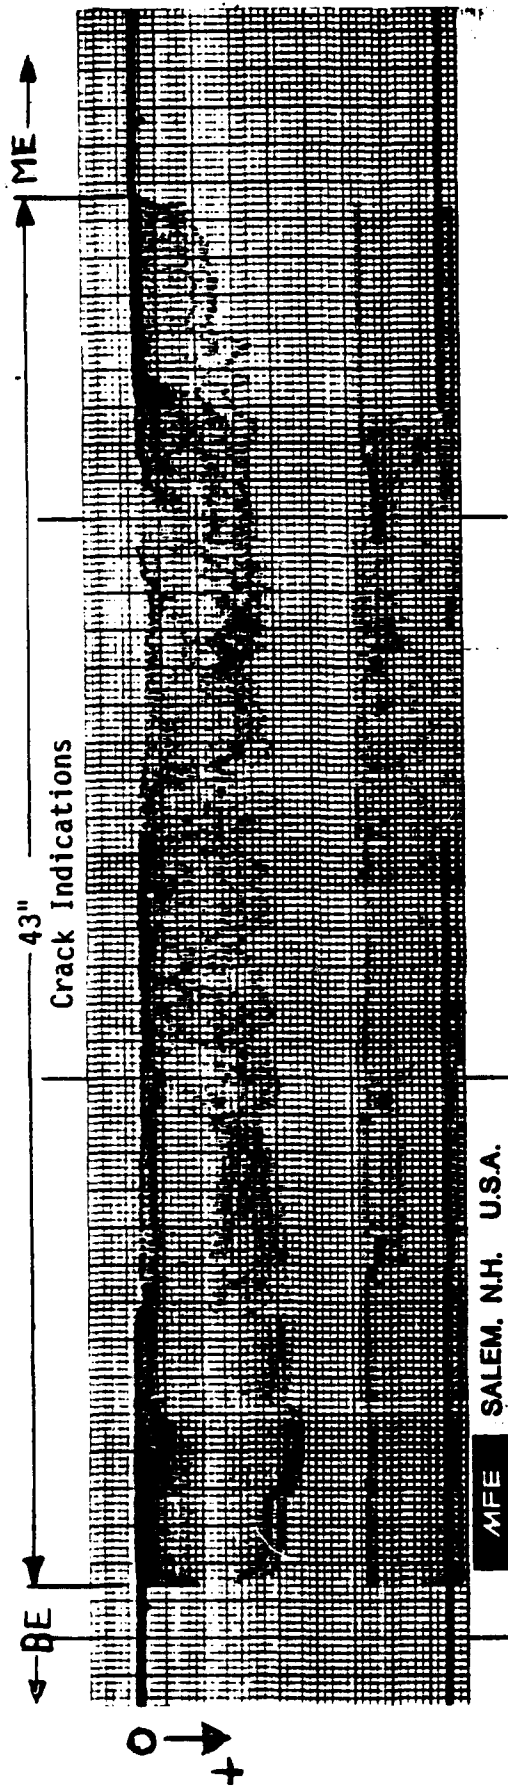
Figure 18. Test results using the surface ride probe on a 105-mm tube (S.N. 2664).

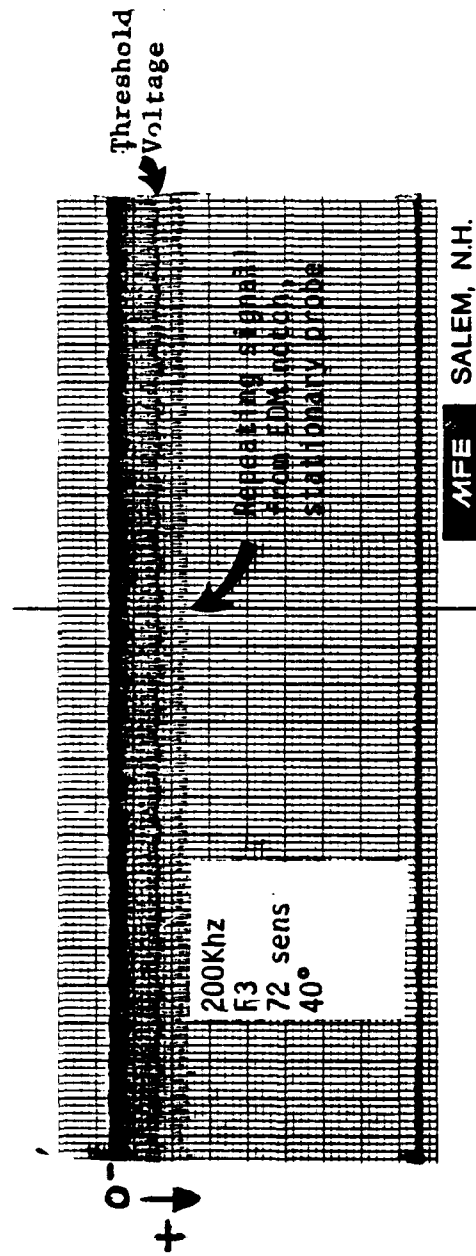
Figure 19. Circumferential EDM notch indications (0.1 inch deep) using the surface ride probe.

Since all the tests conducted up to this point were with tubes containing longitudinal quench cracks, i.e., cracks parallel to the long axis of the tube, additional tests were conducted on a tube segment with a circumferential slot. The slot was produced using electrical discharge machining (EDM) and measured 0.1 inch deep, 1.0 inch long, and approximately 0.01 inch wide. Results of the tests are shown in Figure 19. This figure shows the signal obtained with the rotating sensing coil positioned over the EDM notch. The trace represents a repeating signal obtained each time the sensing coil passes over the notch. The signal level obtained exceeded the threshold value, indicating that a circumferential defect can be detected with this eddy current system if the coil passes over the end of the defect. The signal obtained occurred as the sensor passed the end of the EDM notch. The eddy current sensor requires the change in surface-to-probe distance to produce a detectable signal.

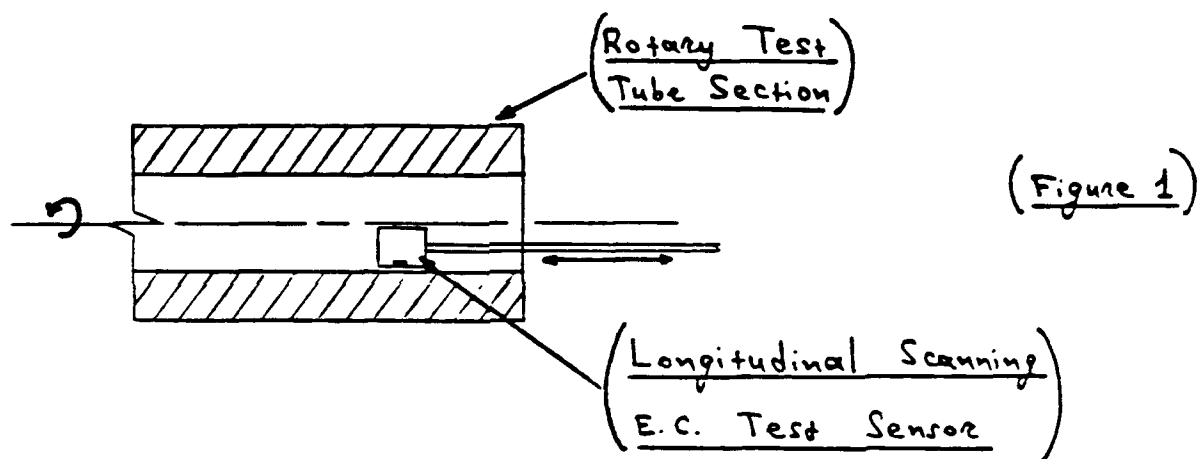
Test Instrument: DE-300
Test Sensor: ZFP-3.3
Test Frequency: 100 KHz
Lift Off: ~ 0.050"
Angular Speed: ~ 150 rpm

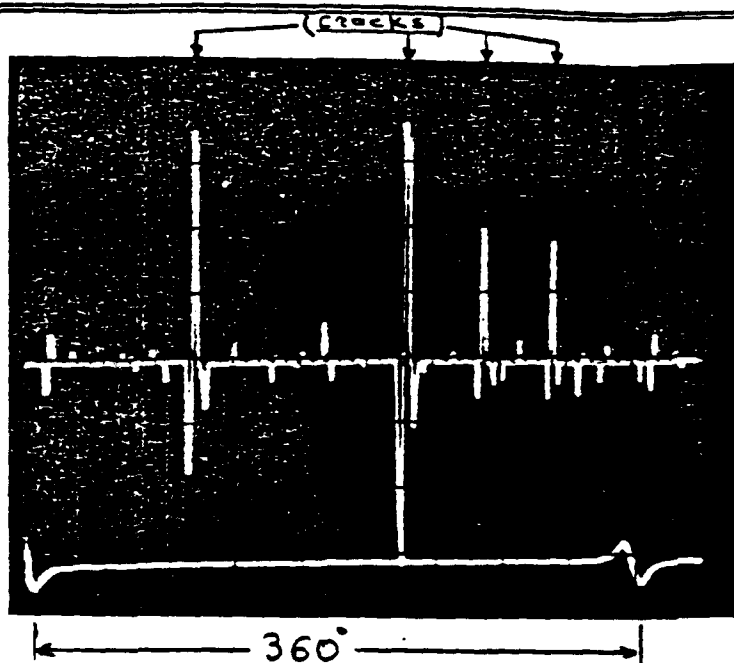
(Figure 2)

Cracked Tube Section:

$$f = 100 \text{ KHz}$$

(Eddy Current
Response Signal)
2 Volts / Division

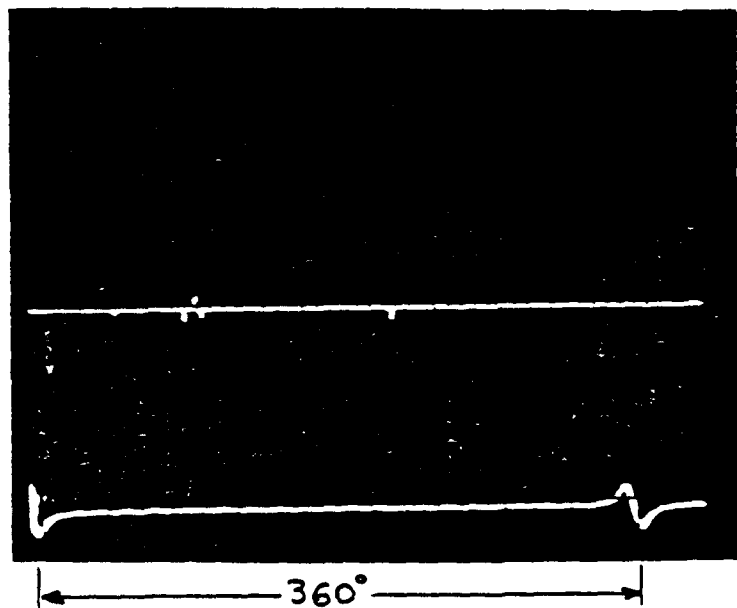
(Figure 3)

Good Tube Section:

$$f = 100 \text{ KHz}$$

(Eddy Current
Response Signal)
2 Volts / Division

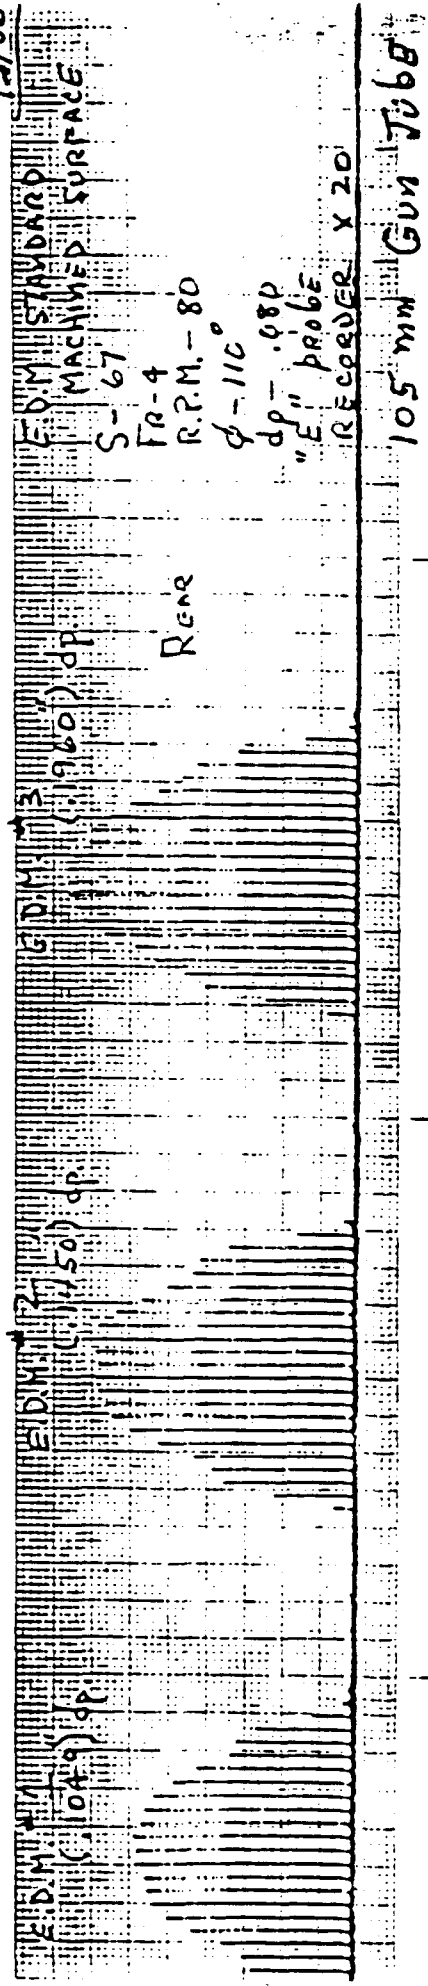
1/3/86
E.D.M. STANDARD
MACHINED SURFACE

E.D.M. #4
(.195 deep)

E.D.M. #5
(.1430 deep)

E.D.M. #6
(.0966 deep)

SEE RECORDING dated 1/3/86

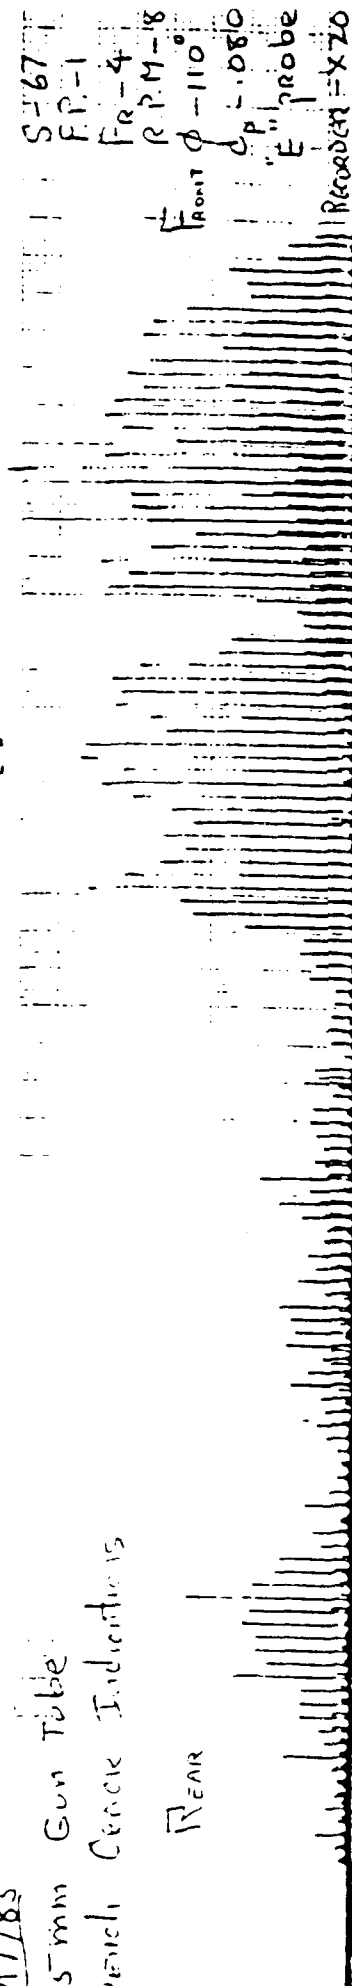
12/17/85

10.5 mm Gun Tube

Probe Stationary

Quench
Crack Ind.

The smaller recording below, also dated 12/17/85, shows that for a complete revolution (probe not being retracted) the noise level between successive indications for a quench crack is extremely low. That is the remaining wall is good & no signal is obtained.

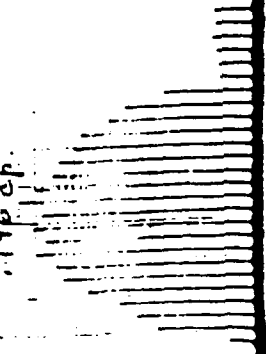
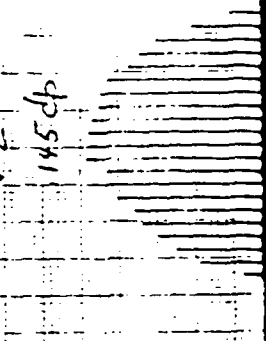
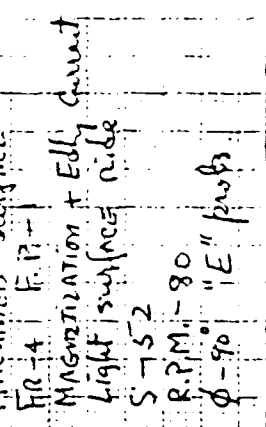
1/7/86
 E.D.M. Standards
 Machined Surface
 FR-4 F.P.
 Magnetization + Eddy Current
 Light Surface Ride
 S-52
 R.P.M. - 80
 ϕ - 90 "E" probe

#3
 .196 ϕ

#2
 .145 ϕ

#1
 .105 ϕ

SEE RECORDING dated 1/7/86
